Manhole Inspection Summary

Manhole # S15II1024MH

Insp Date: **3/12/07 10:21 AM**

Location Address: **2483 COLD SPRING LN**

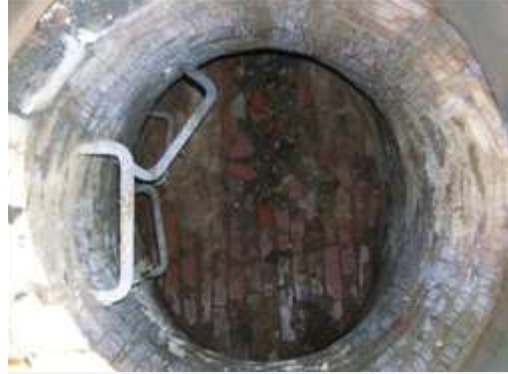
Top View

Channel debris.

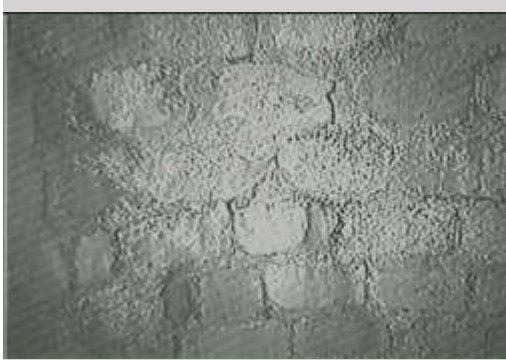
Defect

Barrel infiltration.

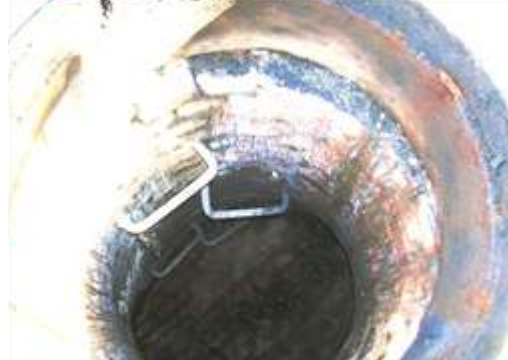
Defect

Frame leaks. Adjustment deterioration and infiltration. Barrel infiltration.

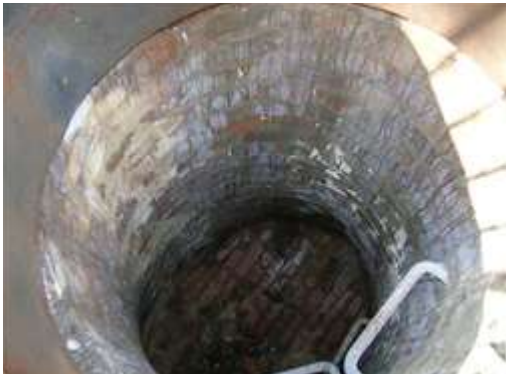
Defect

Adjustment and Barrel infiltration.

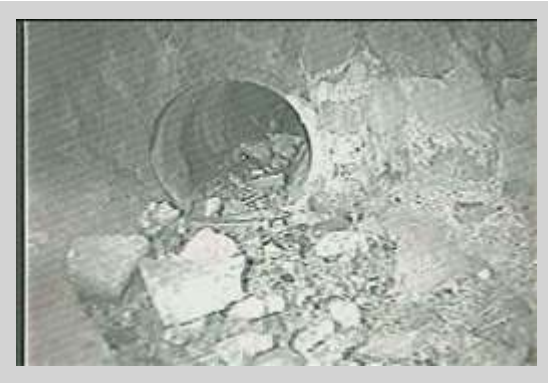
8 in. Circular Gravity Sewer
Pipe Out @ 12 O'Clock

Deposits: ☐ None ☐ Mud ☐ Sludge ☒ **Debris** ☐ Grease

Silt Depth: **1** (in.) Deposits Extent: **Light**
